Storm Damage Report

Brabo International

12122 Jef Drive
Laredo, TX 78045

FIELD REPORT FOR INITIAL STORM DAMAGE INVESTIGATION

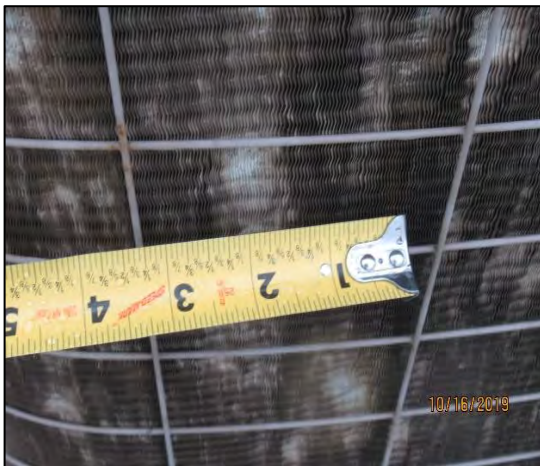
Damage to AC condenser

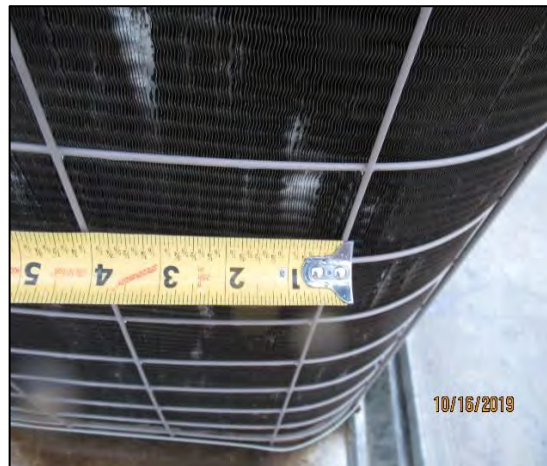
Damage to AC unit

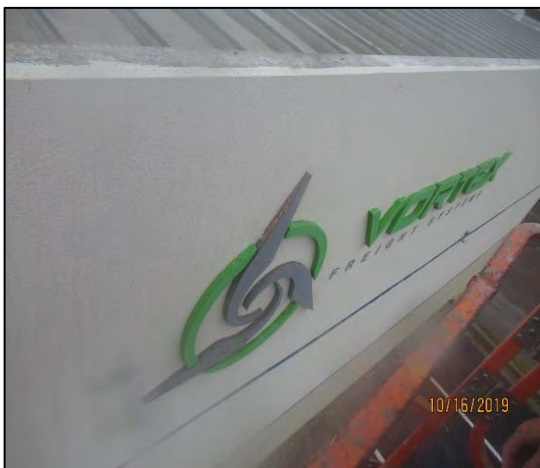
Hail impact damage to sign

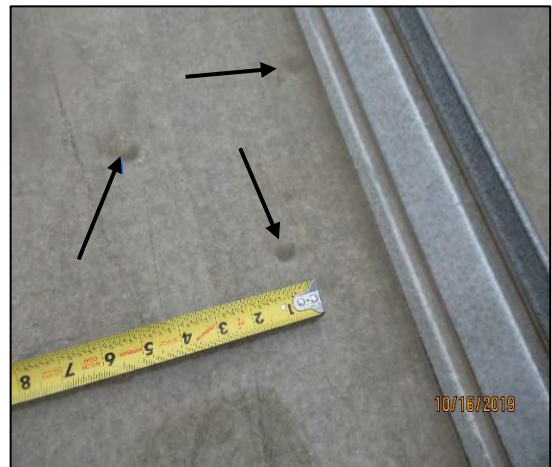
Impact damage to roof

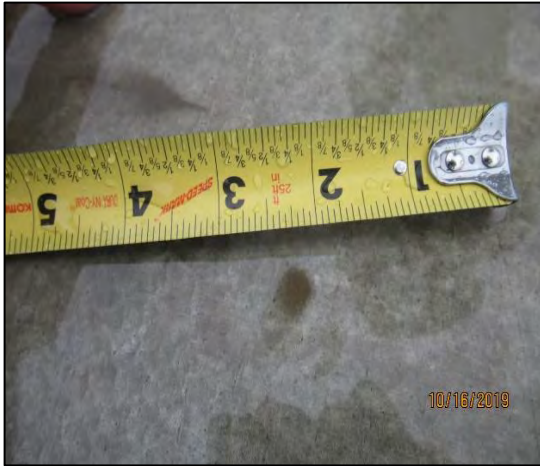
Size of impact damage

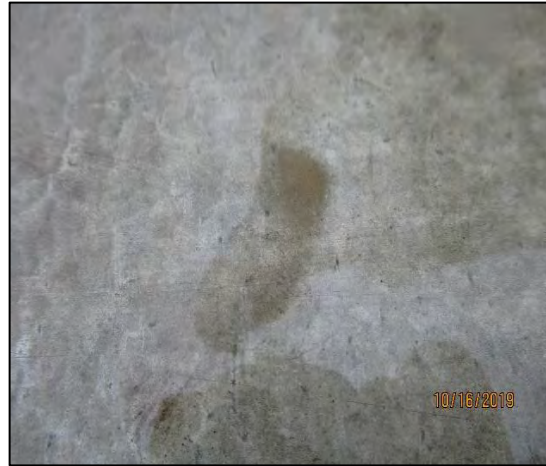
Typical debris/pollutants at an impact

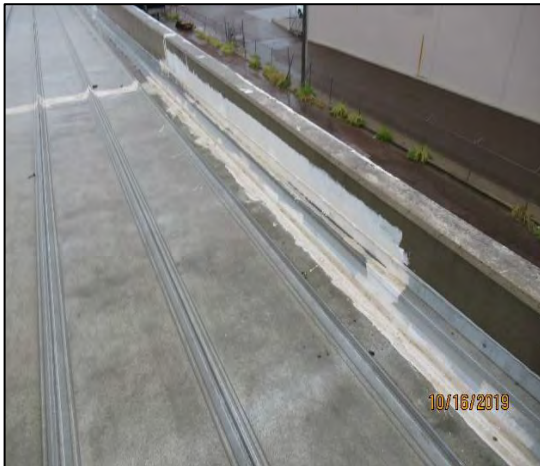
Temporary repairs to roof

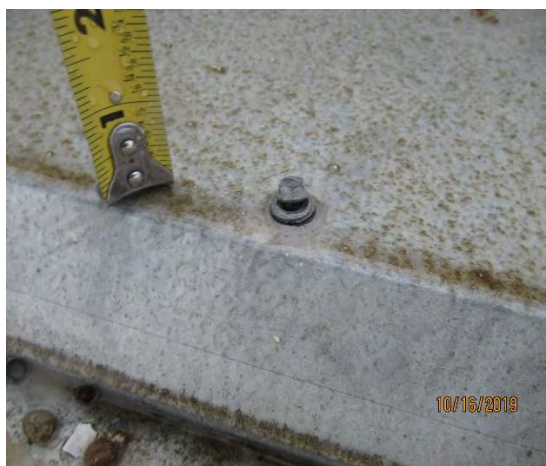
Panel distortion with bent fastener

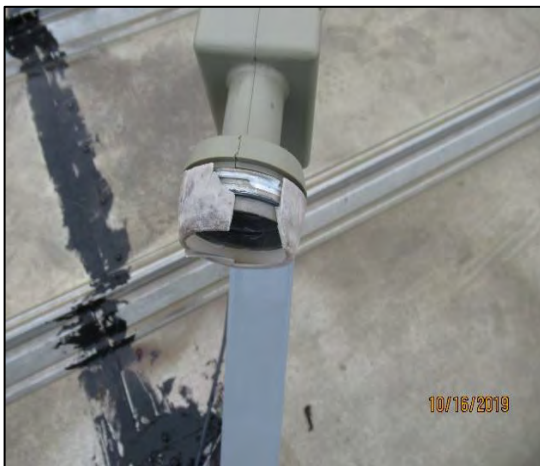
Damaged satellite equipment

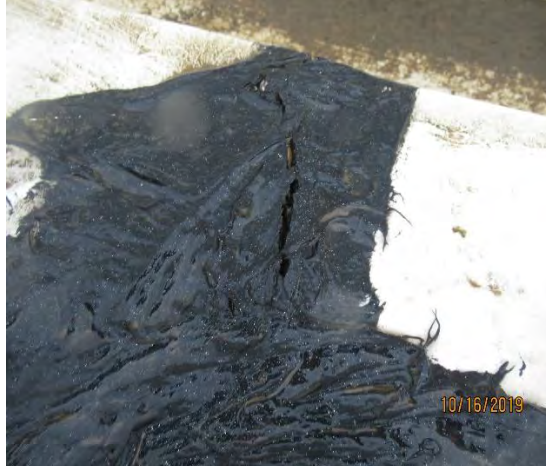
Uplifted panel temporary repair cracked

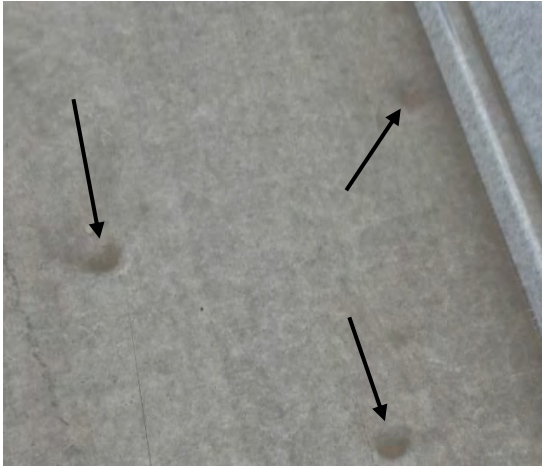
Typical hail impact damage

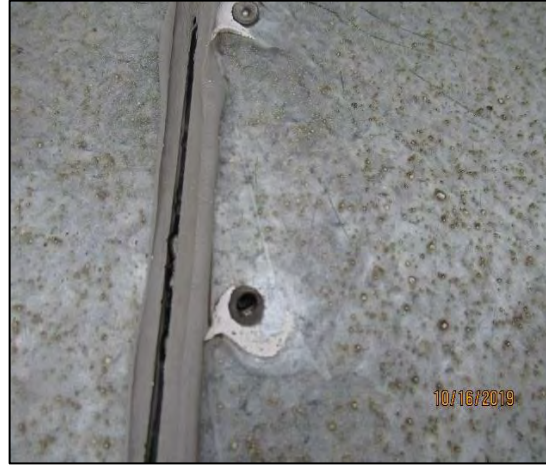
Rivets have been pulled through hole at _ ?

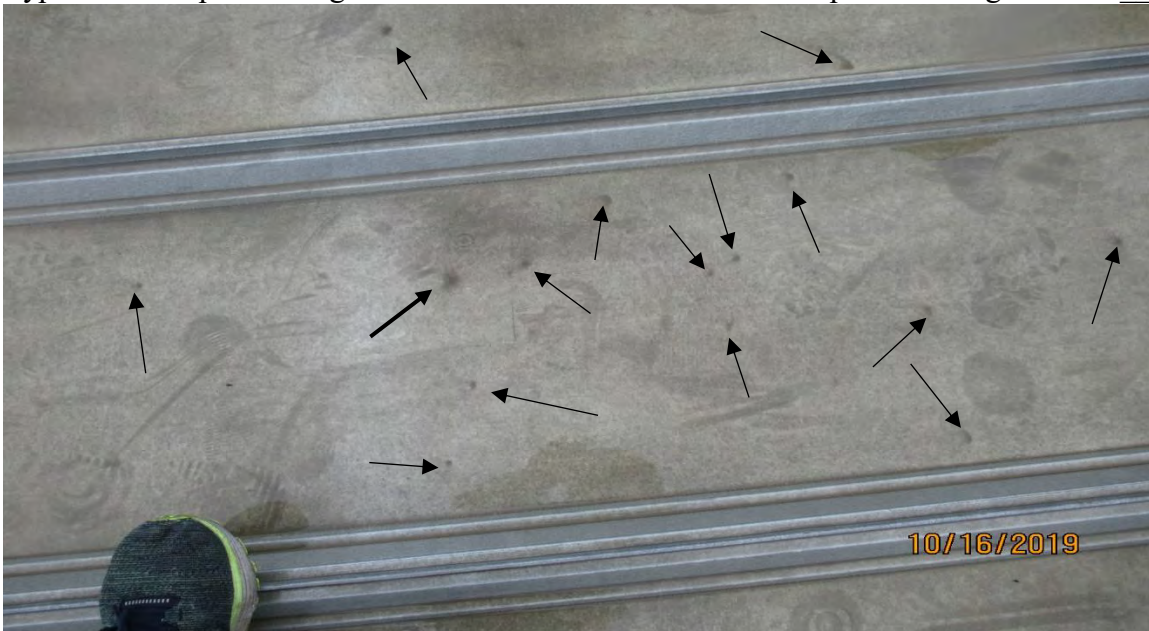
15 hail impacts in 4 x 2 foot area

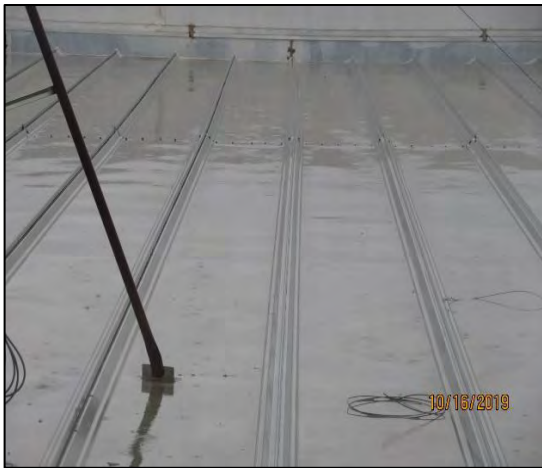
Roof panels detached – typical wind damage observed

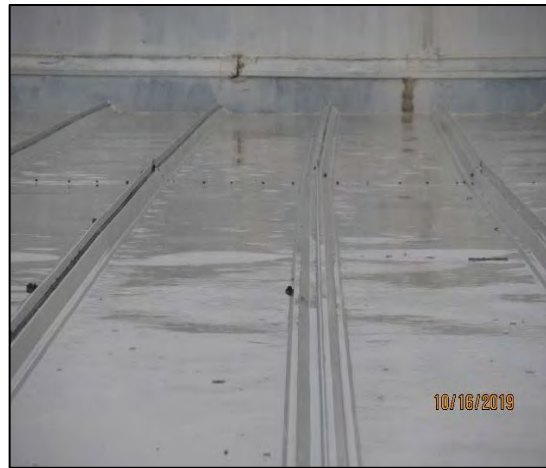
Roof panels detached -panel shift

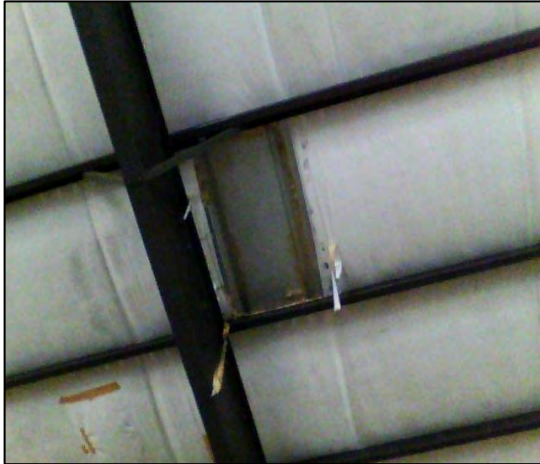
Missing ceiling insulation

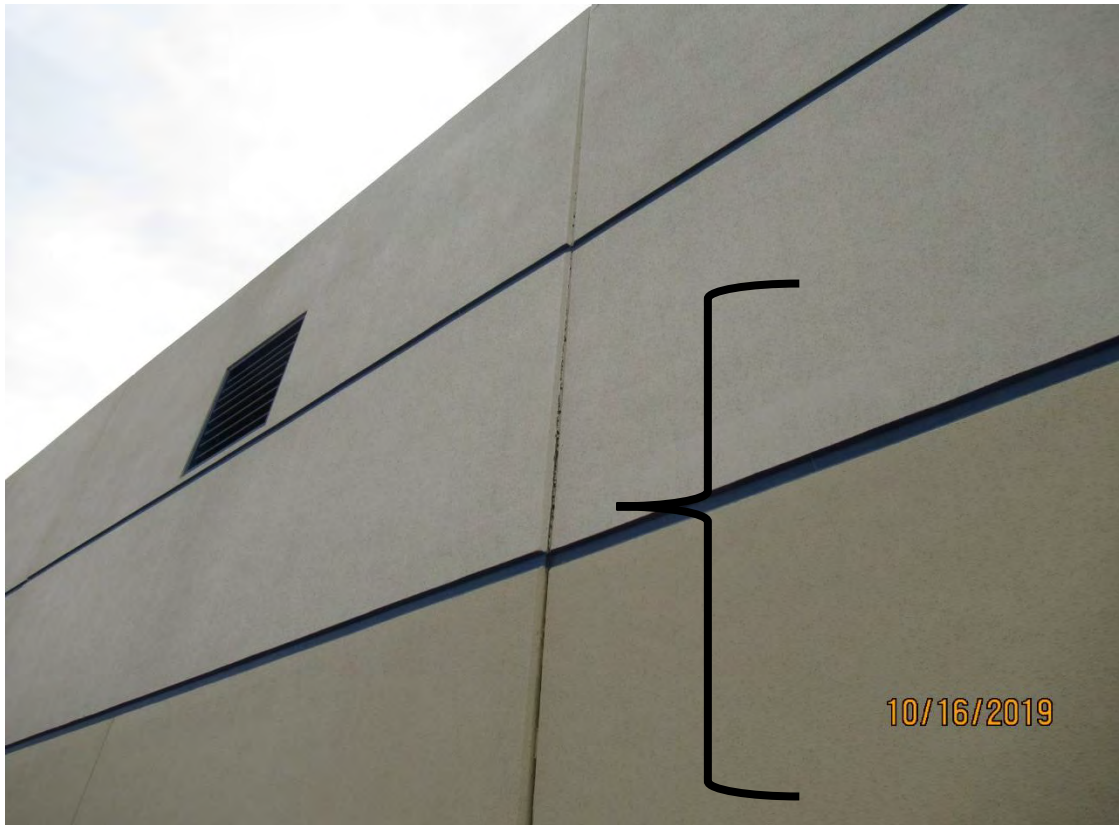
Tilt up panel pushed out of original position due to wind

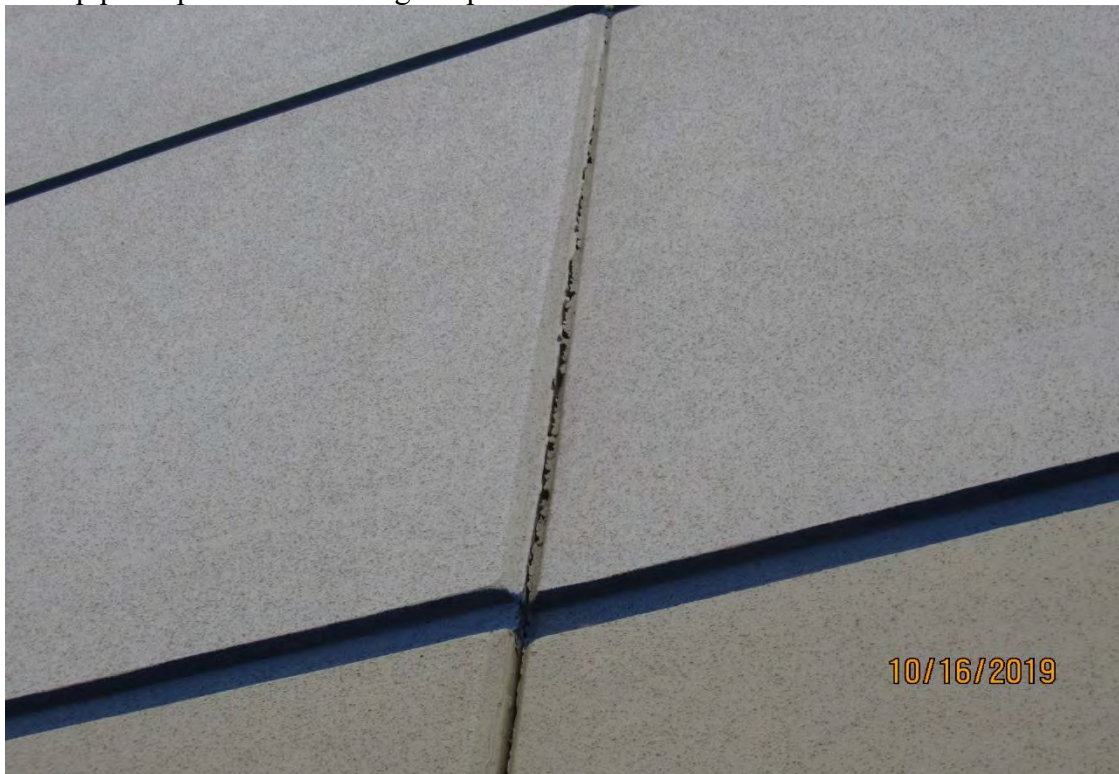
Tilt up panel pushed out of original position

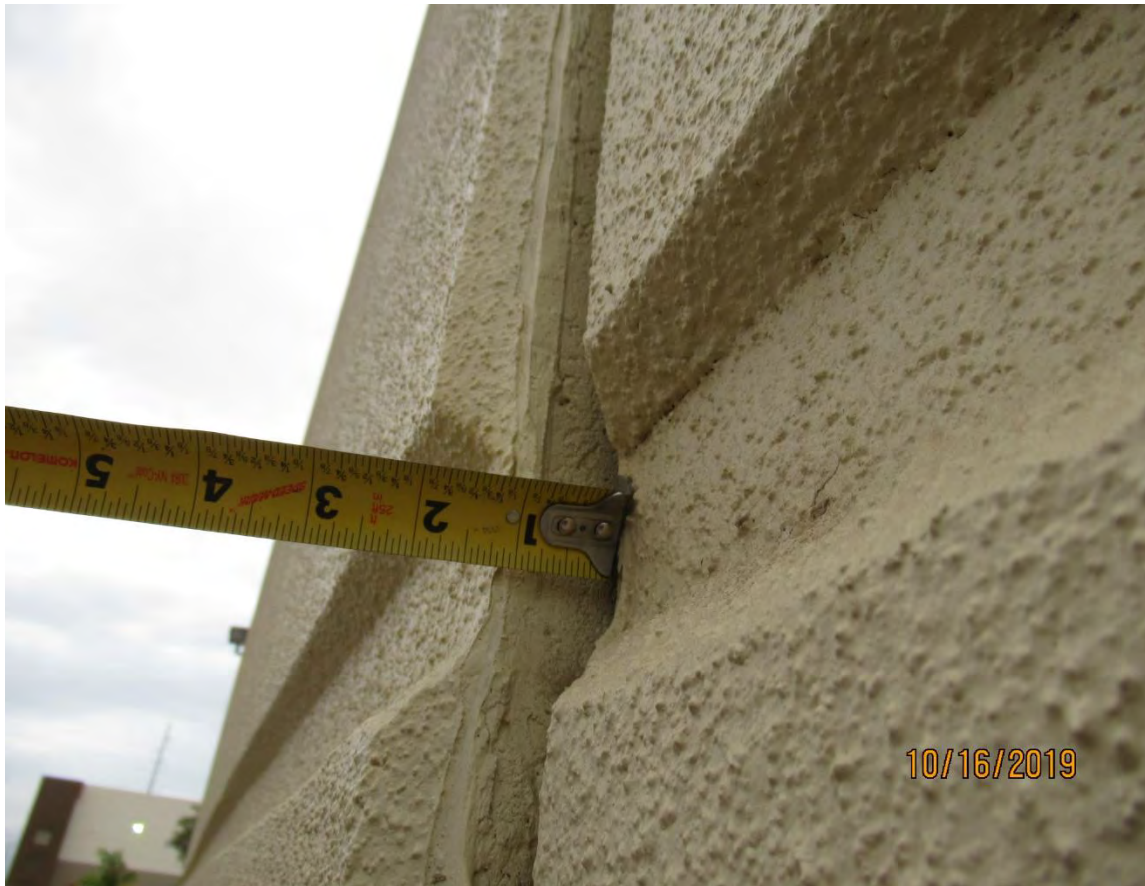
Tilt up panel out of 1" plane

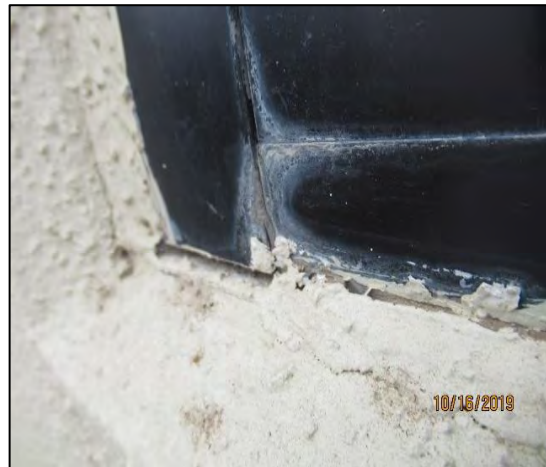
Window frame is damaged

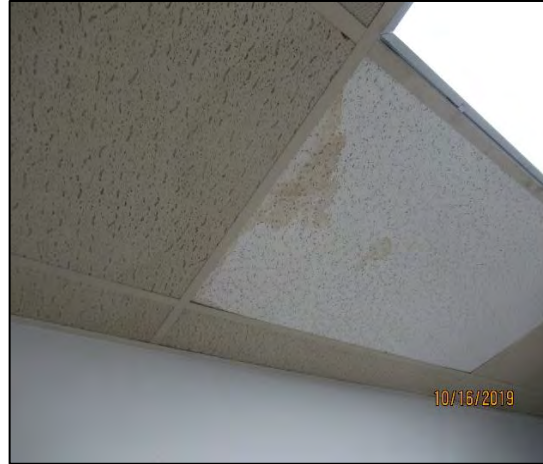
Replaced/damaged ceiling tile

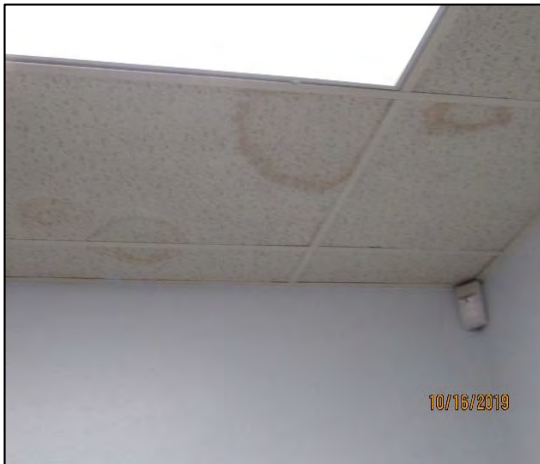
Water damage to ceiling tile

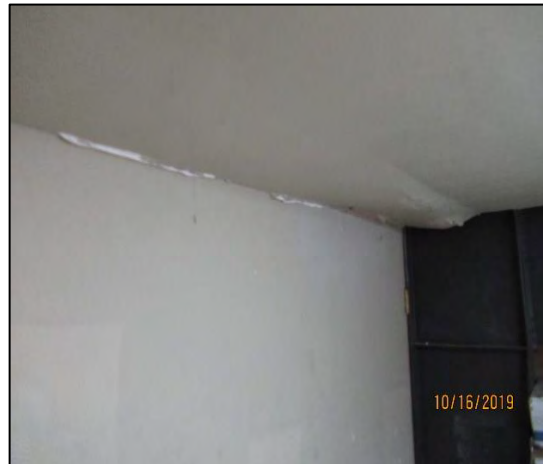
Damage to gypsum board

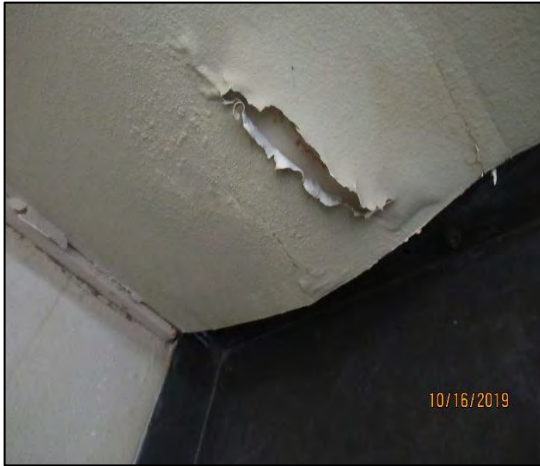
Water damage to paint

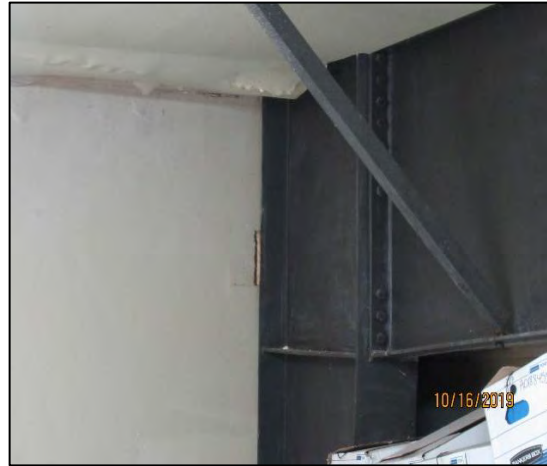
Wall to steel weld is broken at Tilt up panel

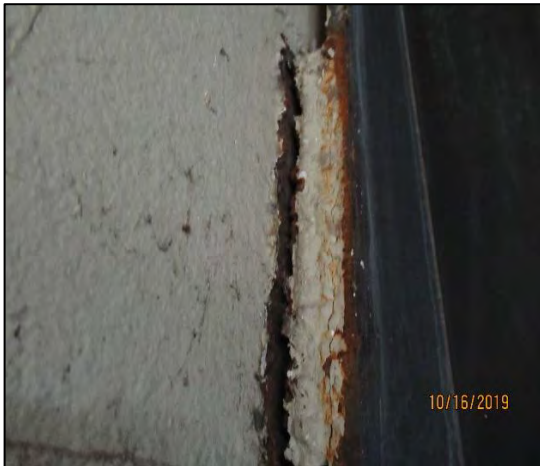
Close-up of broken weld

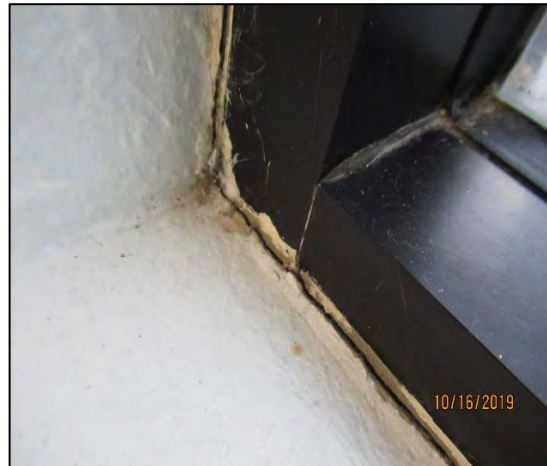
Window frame displacement

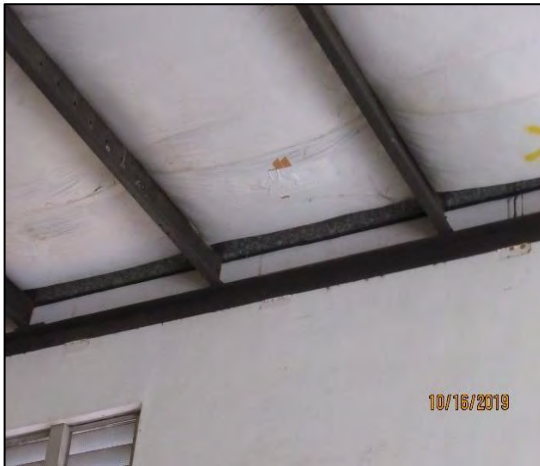
Damaged/repaired ceiling insulation

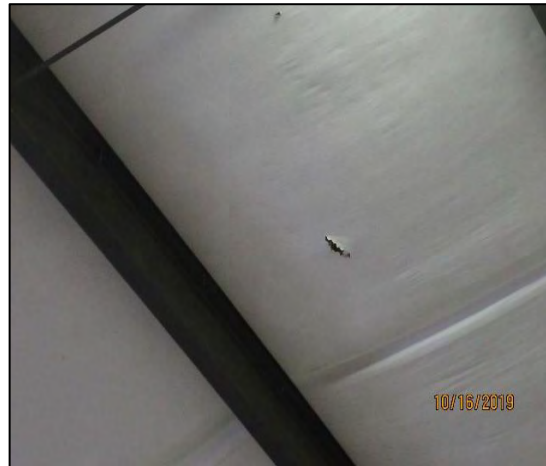
Damaged ceiling insulation below roof deck

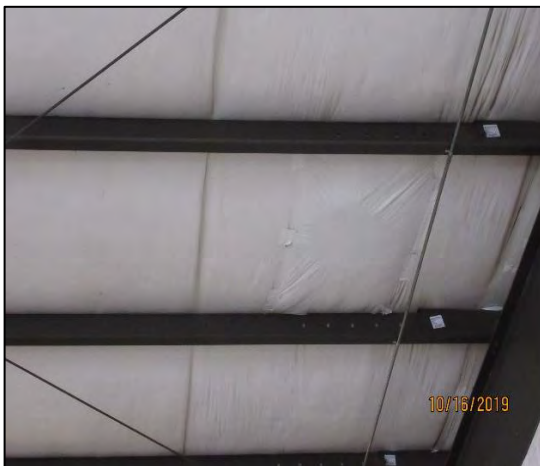
Temporary repair to ceiling insulation

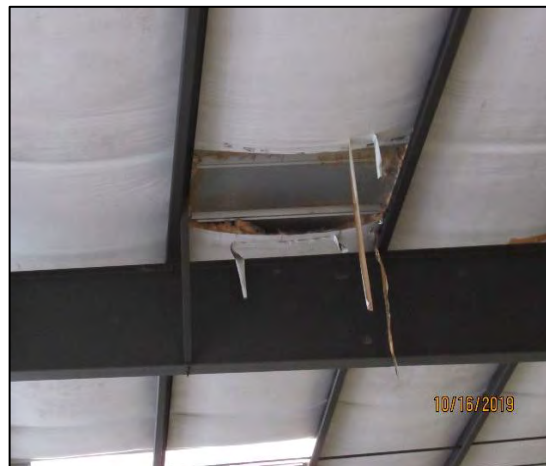
Missing insulation, exposed roof deck

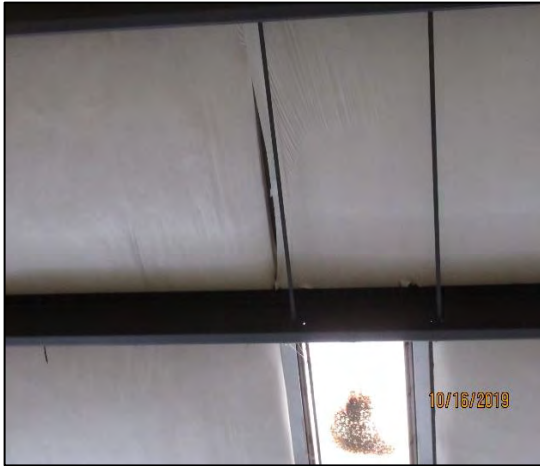
Insulation is displaced

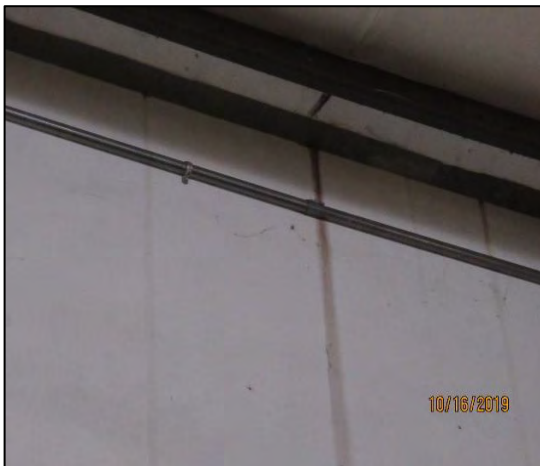
Water damage to wall and paint

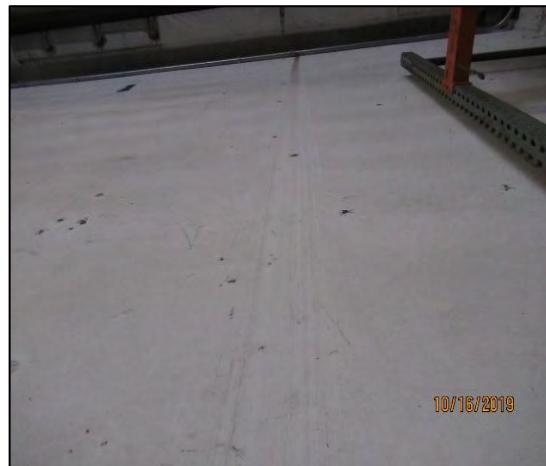
Water damaged area on wall, looking up

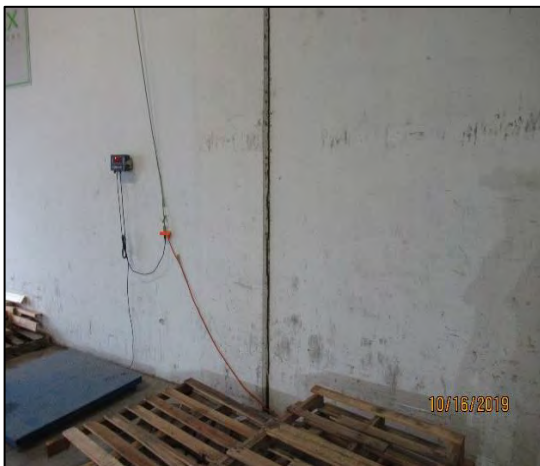
Tilt up panel shifted

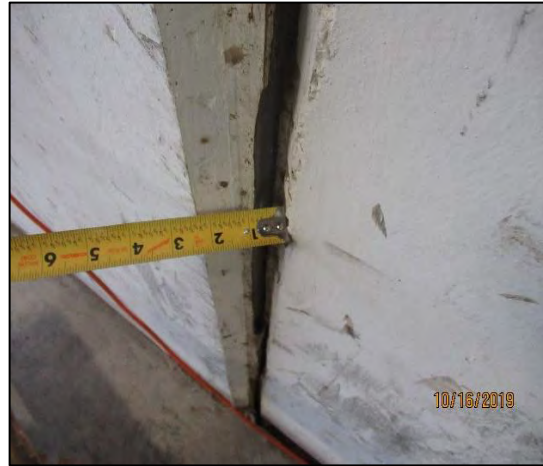
Wall is separated about 3/4"-inch

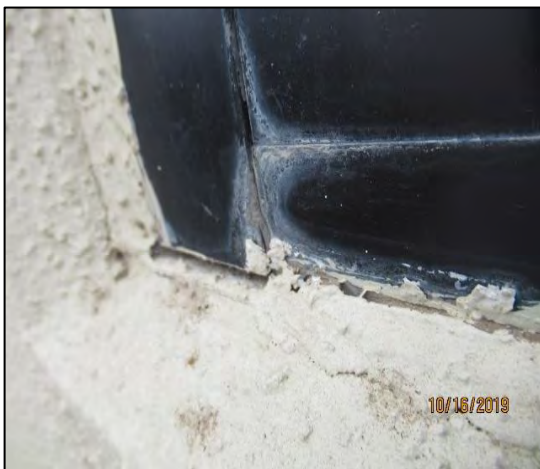
We observed displacement of frame to frame butt joints at intersecting members, we also observed cohesion failure at the intersection of the window frame to rough opening intersections. In our opinion, this cohesion failure was consistent with the hurricane force wind damage during the storm. In other instances, there were clear signs of window frames that had been displaced from their original position. This was also consistent with damage caused by wind. In many cases, water damage was observed around windows throughout the interior.

Frame separation
